# A case of deliberately concealed objects from Argentina (Province of Buenos Aires, 19<sup>th</sup> century)

*This paper describes a peculiar set of objects from the “La Elvira” site, also known as The Bicentennial House in La Matanza, the most populated county in the Province of Buenos Aires, Argentina (Figure 1). These objects were found in the last standing building from “La Elvira”, a 19<sup>th</sup> century productive ranch in the countryside near Buenos Aires City. A project was developed in order to prevent the house from being demolished, as it was considered of historical value. “The Bicentennial House” project consisted of the disassembling and transportation of all the elements of the dwelling, carried out in conjunction with an archaeological survey. During the monitoring of the former activities, the objects presented here were recovered.*

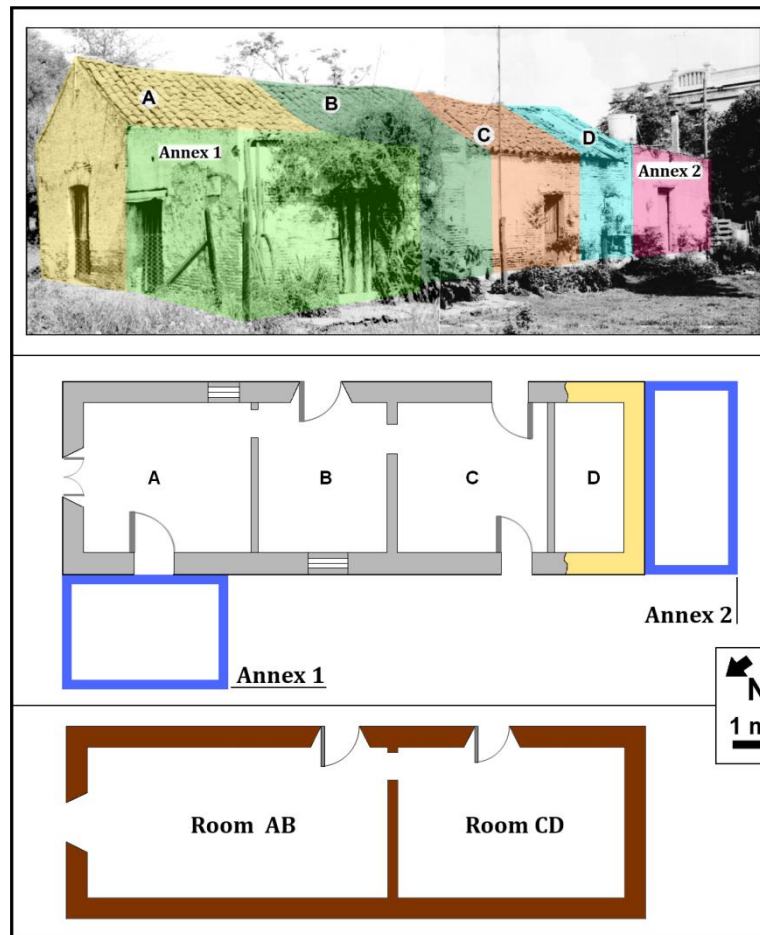
**Figure 2. Top:** Photomontage artificially colored to differentiate the rooms. **Center:** plan of the dwelling, where it can be distinguished: *in gray*, standing remains at the time of the intervention by mid-2011; *in beige*, foundations of room D; *in blue*, foundations of Annexes 1 and 2, probably constructed at some point in the 20<sup>th</sup> century. **Bottom:** in dark brown, recreation of the original structure of the house by early to mid-19<sup>th</sup> century (after Ávido 2012a).

“La Elvira” site consisted of a three-room house (A, B and C in figure 2) which, according to the construction materials and techniques observed before its disassembling, was around 200 years old. A preliminary study of the changes in the structure (Ávido 2012a), the foundations and the roof, along with

other features, showed that the dwelling was originally planned as a two-room house but, after the mid 19<sup>th</sup> century, it was divided into four rooms. Later, two other rooms were annexed. By 2011, when the disassembling and the archaeological survey were carried out, both annexes and room D had already been demolished.

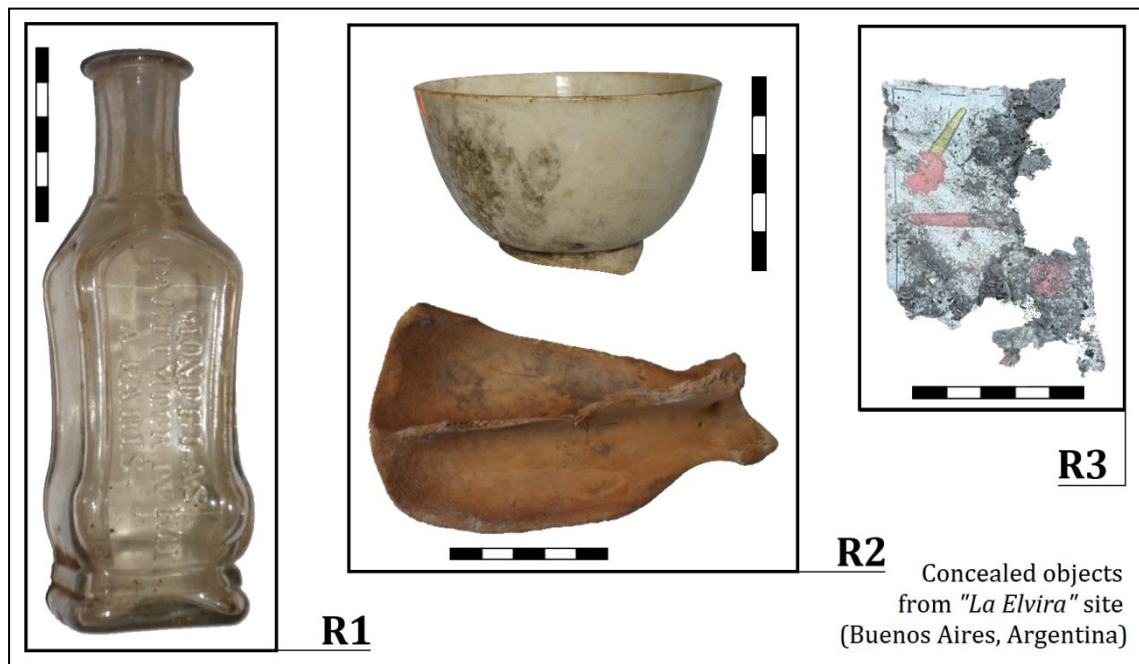
**Figure 3.** Odd findings: objects found inside concealed chambers within the wall (Image Copyright: Daniela N. Ávido).

Among these findings, there were some odd ones: a glass bottle, a playing card, an animal bone and a pot (Figure 3). What was odd about them? They were found inside voids or “chambers” within the walls. These were not just voids between bricks, but structured and sealed chambers within the structure of the wall: their existence was intended. Three of these chambers, located in three different walls, contained the mentioned objects, while other chambers were empty. They could not be seen nor accessed from outside or inside the house, since the walls concealing the chambers had no marks or signals and the plastering had no cracks. Thus, we considered these objects were not accidentally there, like trapped coins between the

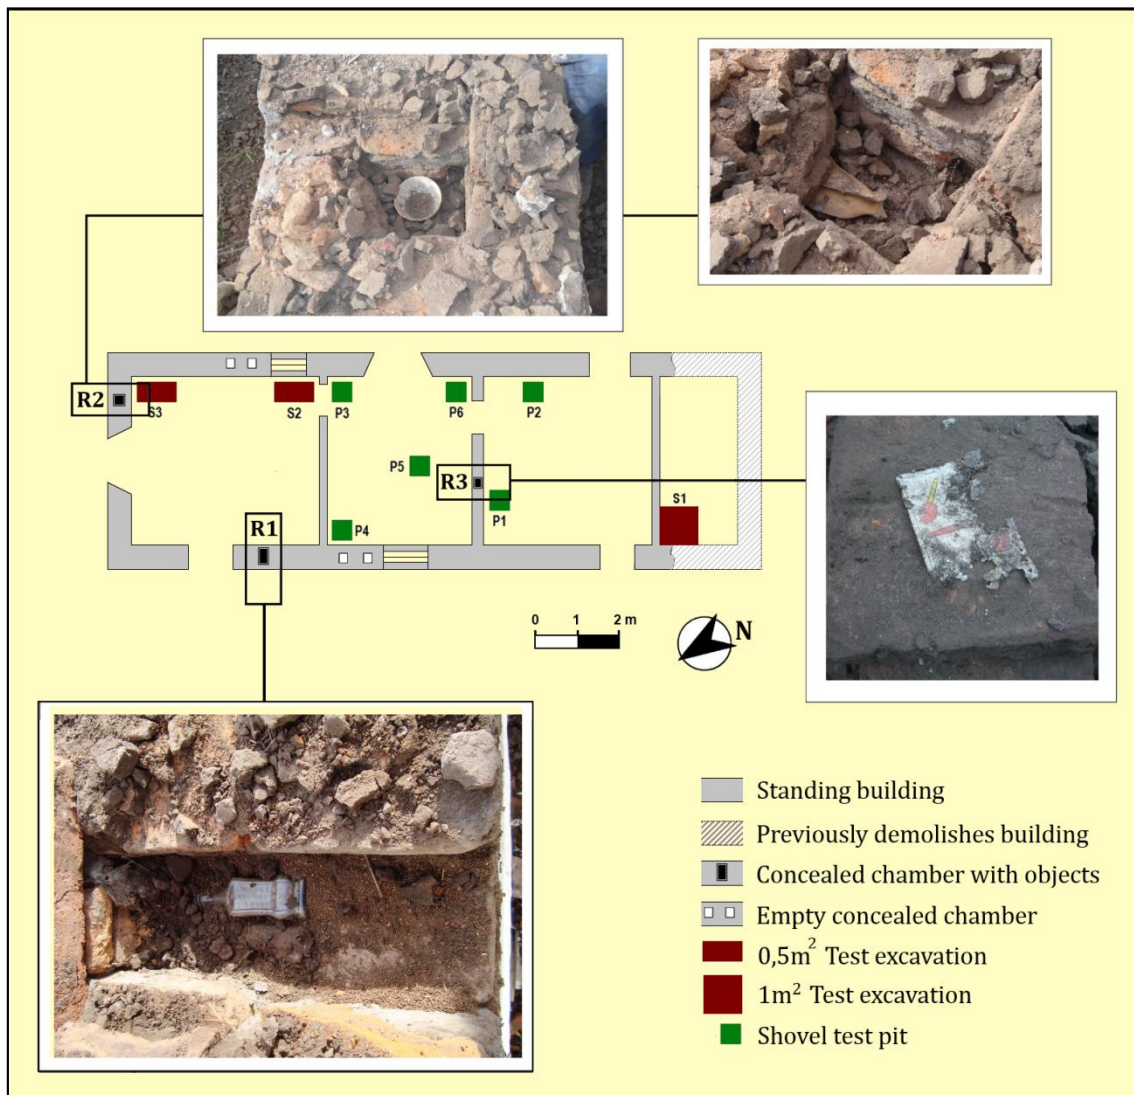
**Figure 4.** Plan of the dwelling showing the excavation units, the location of the concealed objects and their *in situ* contexts. R1, R2 and R3, according to their recovery during fieldwork, stands for Recámara 1, 2 and 3 (“recámara” is the Spanish word for “chamber”) (Image Copyright: Daniela N. Ávido).

cracks of the floorboards; the chambers and their content had more likely been deliberately concealed (Mackay 1991). Figure 4 shows the location of the chambers with concealed objects.

- a) According to the location of the caches (Figure 4), the objects were grouped in three different walls: the perfume bottle was in the NW wall, the playing card was in the SW wall, and the pot and bone were in the NE wall. All three caches enclosed the AB room (Figure 2).
- b) There were some empty chambers in both NW and SE walls (Figure 4). We do not know if they were meant to be empty or if it is a preservation issue.
- c) The perfume bottle from R1 was lying on its side, with its top NW oriented. It was filled with a sawdust-like content, which is to be analyzed.

- d) The pot and bone inside R2 were "mounted" one above the other: the pot was the first to be discovered and, after its collection, the bone was found (see Figure 4).
- e) The bone inside R2 was a canid scapula, probably from a dog. Its spine was incomplete/broken and there were several marks in the glenoid cavity. Furthermore, the pot base was broken and black stained.
- f) The playing card found in R3 was incomplete and lacked its backside.
- g) The perfume maker of the R1 bottle, a French company named Monpelas, started its business in 1830 (Rigone 2008).
